# Inspection Report

**John & Jane Smith**  
456 Center Avenue  
Bigtown, OH 00002

**ROTUNO PROPERTY INSPECTIONS**

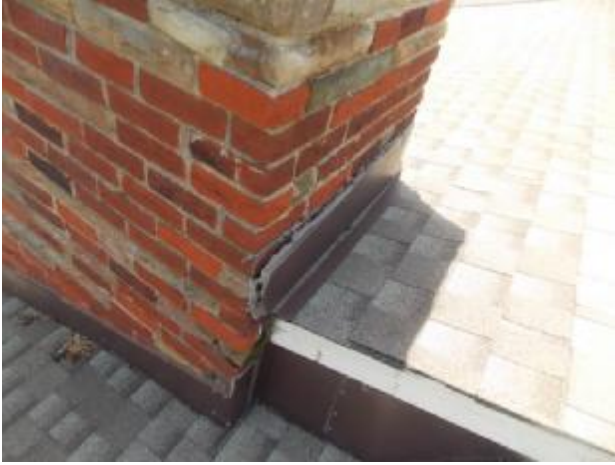
#R1

- 19 1. Flashing has pulled away from the chimney. This can cause water penetration. Recommend a reputable contractor. (see photo 1)

Failing chimney flashing.

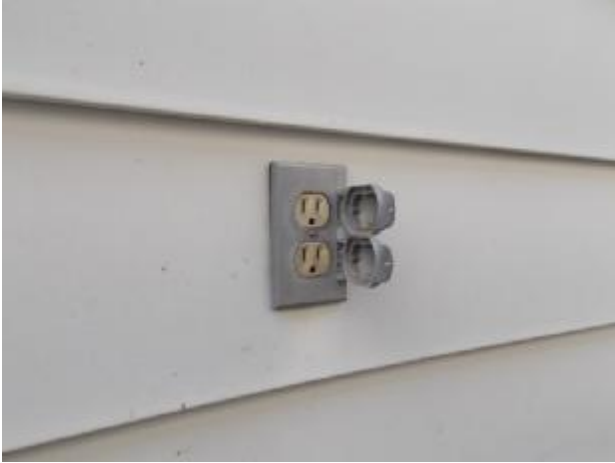
**#EX1**

- 16 1. Outlet covers on the east side of the house do not spring shut. **SAFETY HAZARD.**  
Recommend a reputable licensed electrical contractor. (see photo 1)

**Defective outlet covers.**

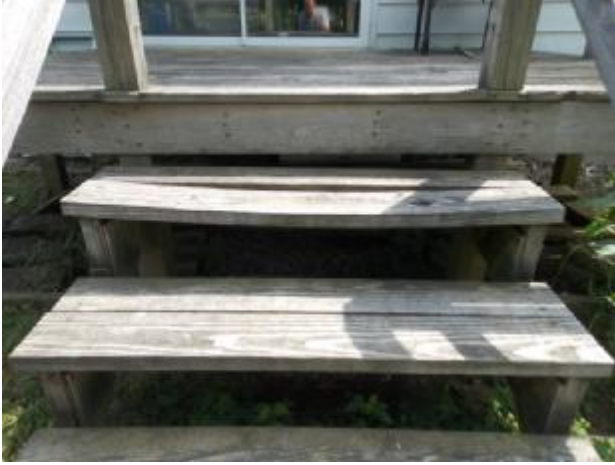
#GD1

- 17 1. One of the boards on the deck steps is bowed and has created a tripping hazard. **SAFETY HAZARD.** Recommend replacing the board. (see photo 1)

**Bent step.**

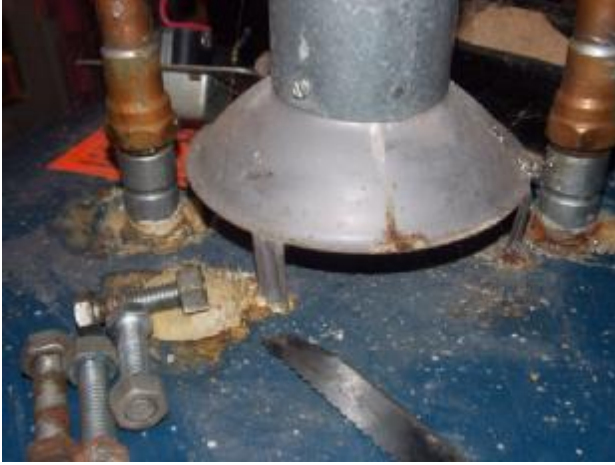
**#P1**

- 20 1. Corrosion on the top of the water heater. Recommend a reputable licensed plumbing contractor. (see photo 1)

**Rusted water heater.**

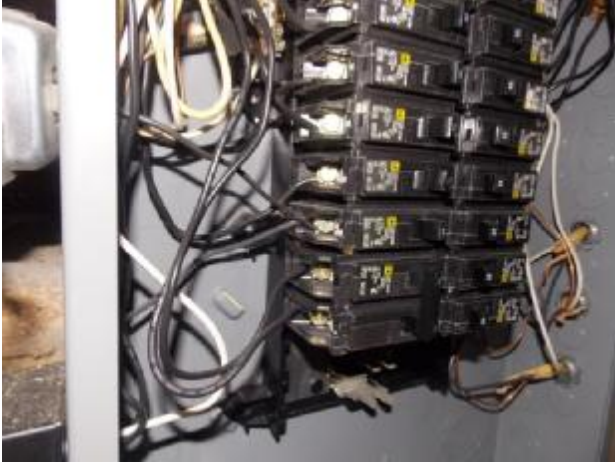
#EL1

19 1. Electrical service panel box contains a double-tap. SAFETY HAZARD. This can overload the circuit. Recommend a reputable licensed electrical contractor. (see photo 1)

Double-tapped breaker.

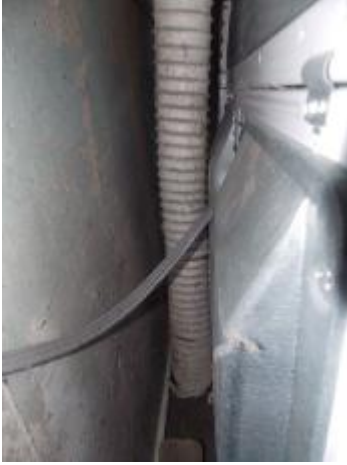
**#K1**

- 26 1. Dryer vent tube is torn in multiple locations. Recommend replacing the vent tube. (see photo 1)

**Torn vent tube.**

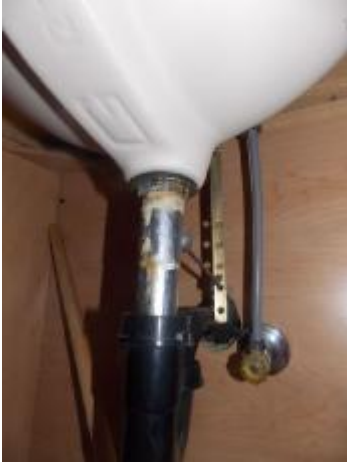
**#B1**

14 1. Corrosion on the pipe under the sink in the downstairs bathroom. Sink does not appear to be leaking at time of inspection. Continue to monitor, (see photo 1)

**Corrosion.**

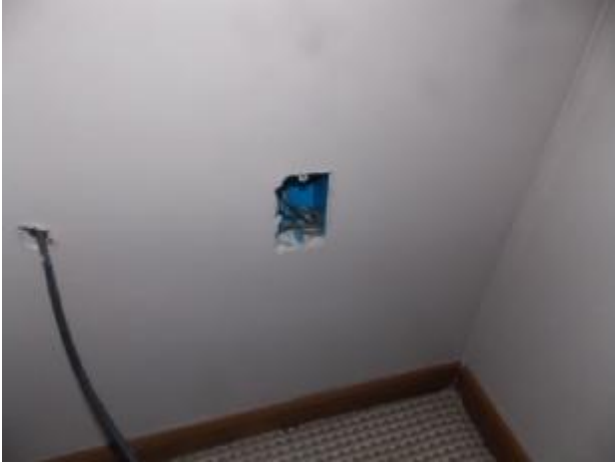
**#IR1**

- 17 1. A live electrical wire in an uncovered junction box in the family room. **SAFETY HAZARD.** Recommend a reputable licensed electrical contractor (see photo 1).

**Exposed live electrical wire**

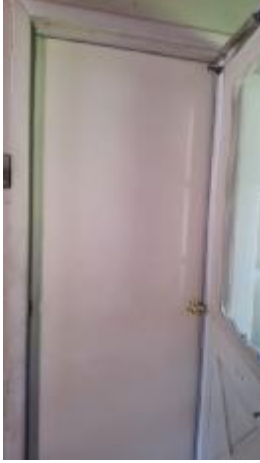
**#GC1**

20	1. Door from the garage to the kitchen is wood and not a thermal fire door. This can allow fumes from the garage to enter the house. SAFETY HAZARD. Recommend a reputable contractor. (see photo 1)

**Improper fire door.**

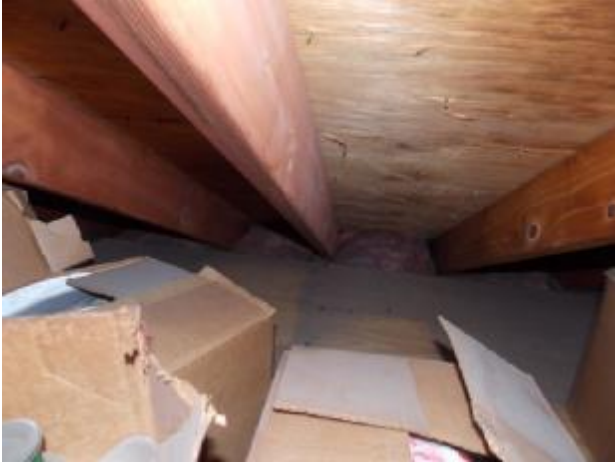
**#AT1**

1. Insulation in the attic is blocking off nearly all the outside air allowed in from the soffit vents, and there is no other avenue for air to enter the attic space. Recommend installing baffles to assist in allowing airflow to the attic. (see photo 1)

**Insulation covering soffit vent.**

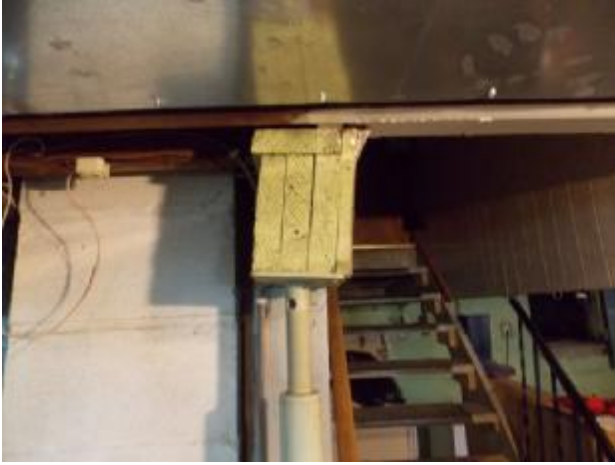
#F1

1. Built-up girder is listing and is causing the steel column's cap plate to bend. Recommend a reputable licensed structural engineer. (see photos 1)

Listing girder.
